Manhole Inspection Summary

Manhole # S33MM1001MH

Insp Date: **2/27/07 2:08 PM**

Location Address: **10 CHARLCOTE PL**

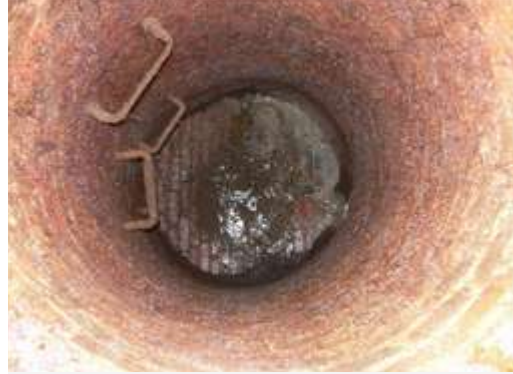
Top View

Corroded steps. Channel debris.

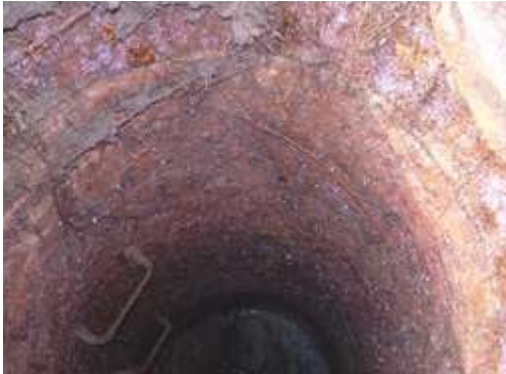
Defect

Frame Offset: **0** (in.) Condition: ☐ Sound ☐ Cracked ☒ **Leaks**

Condition: ☐ Sound ☐ Cracked ☒ **Root Intrusion** ☐ Loose Brick ☐ Deteriorated

Infiltration: ☐ None ☒ **Joint** ☐ Cracks ☐ Mortar ☒ **Roots** ☒ **Wall**

Frame leaks. Adjustment root intrusion and infiltration.

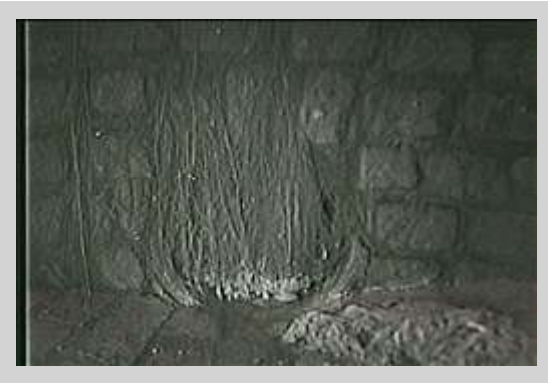
Pipe Out @ 12 O'Clock

Barrel root intrusion and infiltration.

Infiltration: **None** Pipe Seal Cond: **Roots**

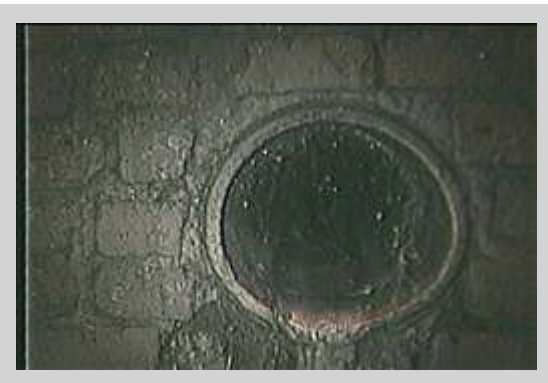
Pipe In @ 3 O'Clock

Infiltration: **None** Pipe Seal Cond: **Roots**

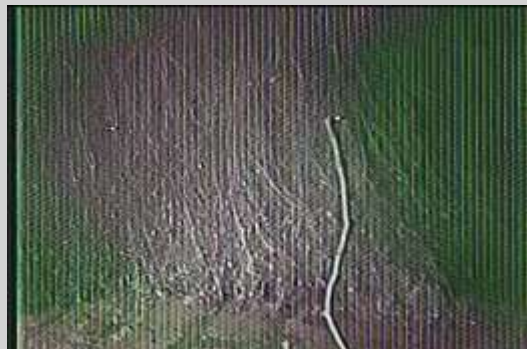
Pipe In @ 5 O'Clock

Pipe Seal Cond: **Roots**
